SURGICAL TOOTH IMPLANTS, COMBAT AND FIELD

Annual Report

Craig R. Hassler, Robert H. Downes,
and Larry G. McCoy

July 1981

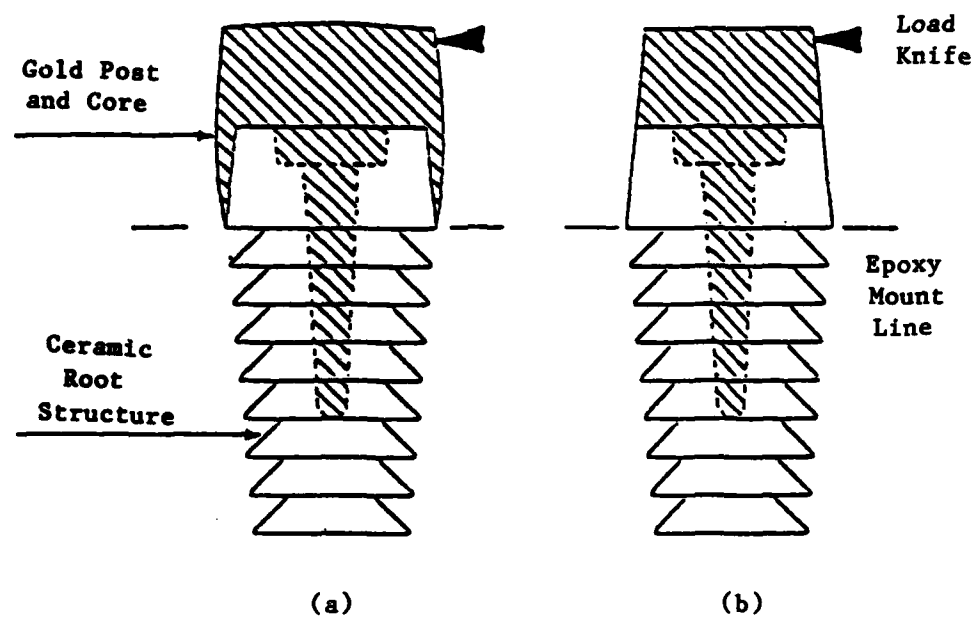
The lower portion of our three-piece implants are produced from alumina (Al_2O_3) (Figure 1). This portion has large serrations into which bone ingrowth has been demonstrated.⁽⁴⁾ A variation of the implant illustrated in Figure 1 has smaller serrations at the crown end of the root to increase the strength of smaller sized roots in these critical areas. The upper two portions of the implant: post and core and crown - are cemented after ingrowth to allow function. The three-piece design allows minimization of occlusal stresses on the implant to facilitate bone ingrowth. An analogous situation is seen in the healing of long bone. It is assumed that as in long bone an orderly transition through a sequence of gradually stiffer bone materials proceeds (hematoma connective tissue woven bone compact bone). The maximal strain which any of these tissues can withstand must not be exceeded if healing is to proceed to completion.⁽²¹⁾ Consequently, strain upon the implant-bone interface must be minimized early in the healing process if bone formation is to occur. Once the implant is stabilized by ingrowth, the large implant surface area at right angles to the principal load axis of the implant is intended to maintain bone stresses below a level which produces resorption of bone. Attempts to quantify these stresses have been made in this laboratory.⁽⁹⁾ This information is not specifically for alveolar bone. However, it serves as a guide in an area where no direct information is available. As demonstrated by histologic data collected on this project⁽²⁾, the hypothesis appears to be viable and bone can exist successfully in direct contact with a functional implant.

FIGURE 1. POST DESIGNS FOR CERAMIC ROOT STRUCTURES
(a) OVERLAP DESIGN, (b) FLUSH DESIGN

Two post and core designs are possible (Figure 1). In the first design the gold overlaps the outside of the root structure and extends downward into the gingival sulcus. The second design is formed flush with the exterior surface of the alumina. The prosthodontist prefers the use of the first design to maximize the strength of post/ceramic interface. The use of this design, however, necessitates setting the implant higher in the alveolar bone, which could impede the bone healing process. Also, the extended gold margin can irritate gingiva.

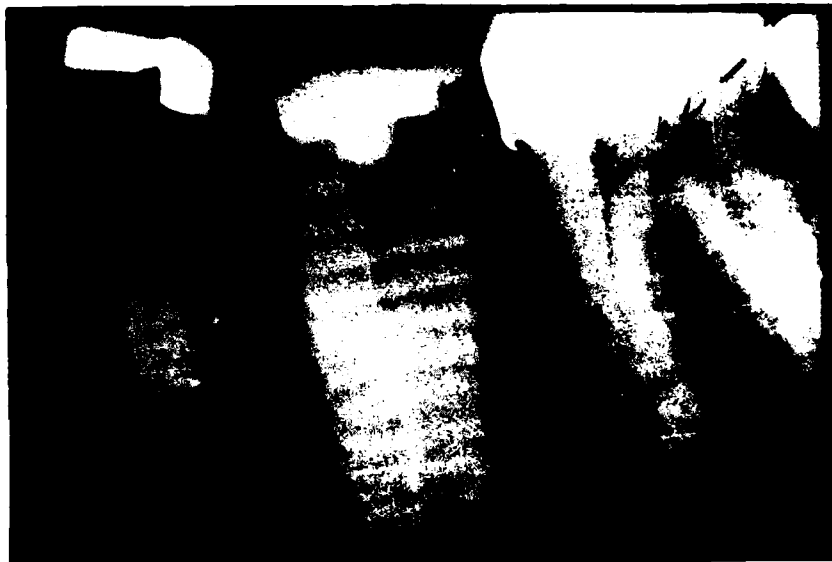
FIGURE 10. HUMAN PATIENT RADIOGRAPH AT TIME OF SURGERY. THE IMPLANT WAS PLACED IN A FRESH EXTRACTION SITE A 19. NOTE THE IMPLANT WAS PLACED CONSIDERABLY ABOVE THE ALVEOLAR CREST.
